## Kaldera 6 KAL6-N-SW-NO

BV-2.1\_0047(B)

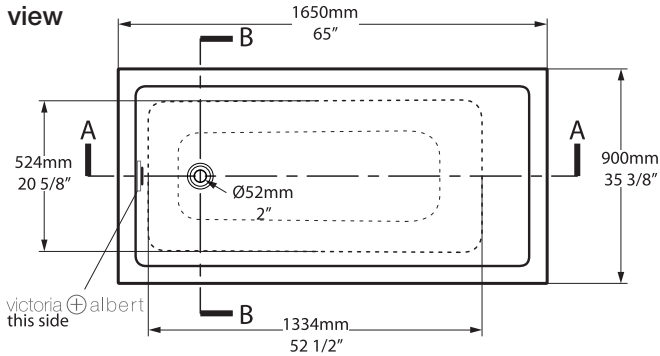
Top view

Drop In Cut Out

1619mm x 857mm  
63 3/4" x 33 3/4"

UnderMount Cut Out

1584mm x 835mm  
62 3/8" x 32 7/8"

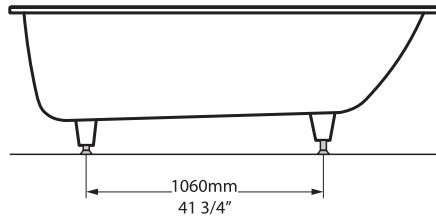
Side view

Section AA

Note: Optional overflow hole needs to be drilled on site in Australia by installer

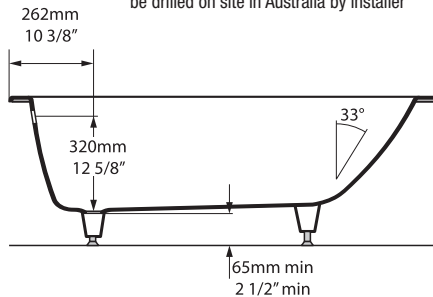
Front view

Section BB
